# NewsLetter

March 2007

## The Container that caused an accident on board

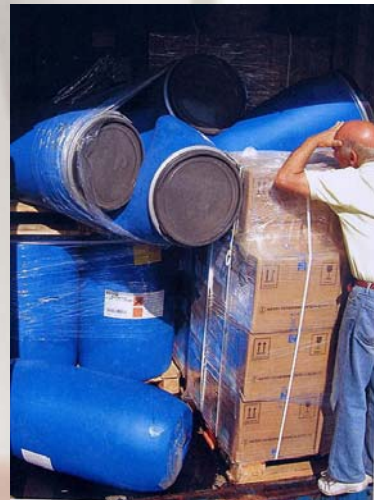
The photograph below relates to a container that was recently discharged from the vessel SUSAN BROCHARD in Geneva. The crew discovered leakage underneath the doors of the container. Inside the LCL container there was corrosive cargo IMO.8 together with general cargo. TRANSPORT MANAGEMENT EUROPE n.v. acts as liability insurer of the freight forwarder that loaded the container on board the ship.

The surveyor found that the leaking occurred for the out of ordering of the drums of Dehyton PS owing to improper stowage and lack of lashing of the pallet stowed at second tier. With an empty space of about 60 cm not secured.

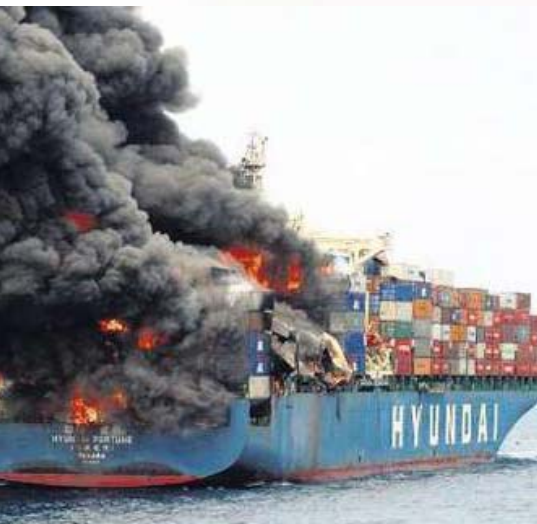
On March 21<sup>st</sup> 2006, the 64.000 Tons and 5.500 Teus ship HYUNDAI FORTUNE, built in 1992, was on its way from ports in China and Singapore through the Gulf of Aden, 60 miles south of the coast of Yemen, when a huge explosion of unknown origin occurred below deck and aft of the accommodation, sending 60 to 90 containers tumbling into the ocean. The explosion caused a massive blaze that spread through the stern of the ship, including the accommodation and the stacks in front of the accommodation. Secondary explosions followed as 7 containers full of fireworks also ignited above deck on the stern. The combined cost of the ship and lost cargo is now estimated at over 500 million US Dollars. The cause of the explosion is still to be known and disclosed.

Here we can see a photograph of how the fire developed on board the vessel HYUNDAI FORTUNE.

Damage to cargo was insignificant, but looking at the Hyundai Fortune photograph, it can be seen that a very simple bad job can lead to an extraordinary and serious accident at sea.
